Manhole Inspection Summary

Manhole # S47E__049MH

Insp Date: **7/29/08 9:42 AM**

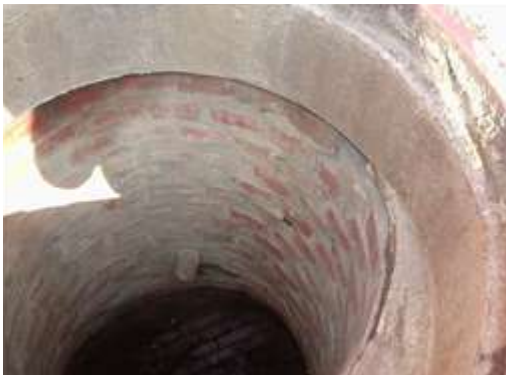
Defect 1

Infiltration: ☐ None ☐ Joint ☐ Cracks ☐ Mortar ☐ Roots ☒ **Wall**

infiltration

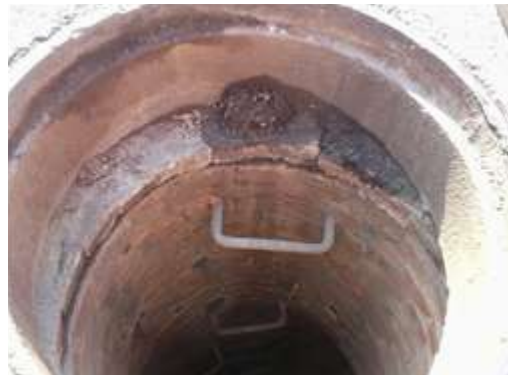
Defect 2

Frame Offset: **4** (in.) Condition: ☐ Sound ☐ Cracked ☒ **Leaks**

frame leaks

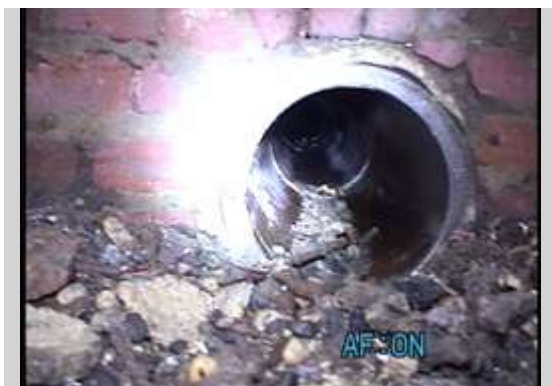
12 O'Clock Outflow

8 in. Circular Gravity Sewer
Pipe Out @ 12 O'Clock

Infiltration: **None** Pipe Seal Cond: **Sound**
